Trickle Fill Project

West Tule Creek, South Fork of the Trinity River

In 2017, the [Watershed Research and Training Center \(WRTC\)](#), based in Hayfork, California began working on the West Tule Creek Fish Passage and Trickle Fill Project.

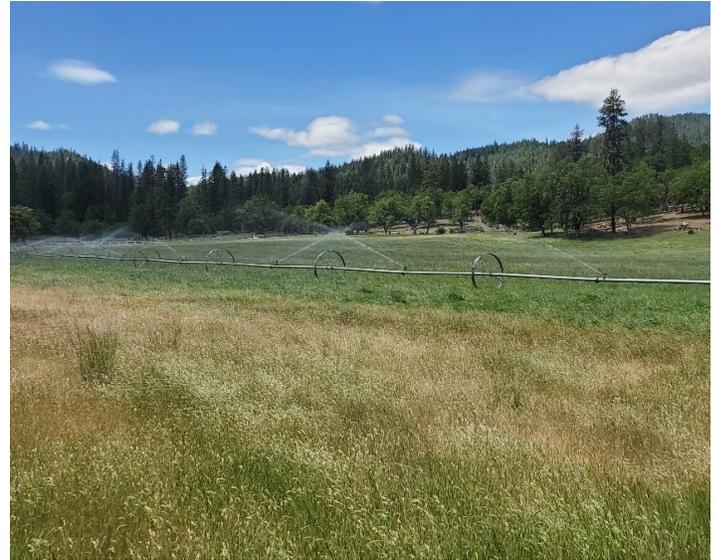
Figure 1. One of five fields being irrigated using water from the trickle fill pond.

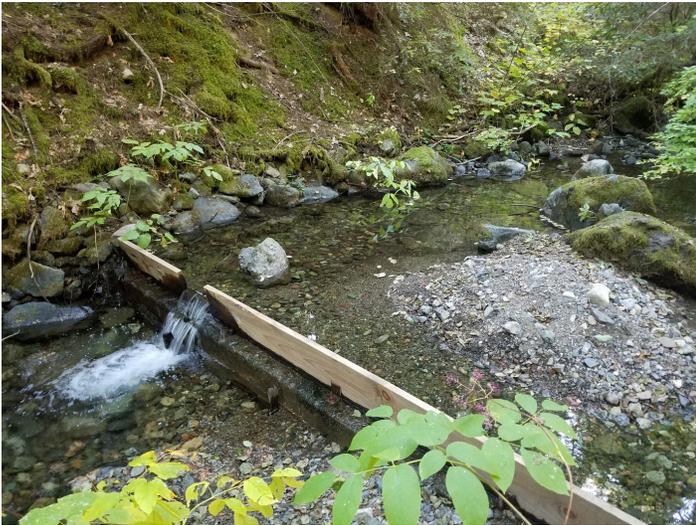
Figure 3. The current diversion that will be replaced with a fish friendly structure.

The goal was to remove an existing fish barrier and replace the diversion with a fish friendly structure and fish screen. The project also upgraded the current irrigation infrastructure from an “on-demand” to a “trickle-fill” system that utilized a pre-existing storage pond. This new “trickle-fill” system would deliver a smaller amount of water to the pond consistently. The existing “on-demand” system diverted a larger amount of water from the stream- resulting in the periodic drying of West Tule Creek downstream.

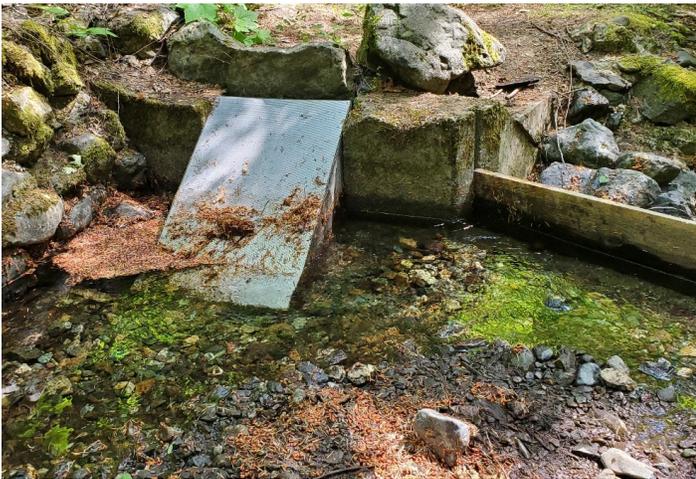
Figure 4. The current fish screen that will be replaced with a lower maintenance screen.
